Property Inspection Report for:

123 Main Street  
Round Rock, TX 78717

# PROPERTY INSPECTION REPORT

08/27/2012

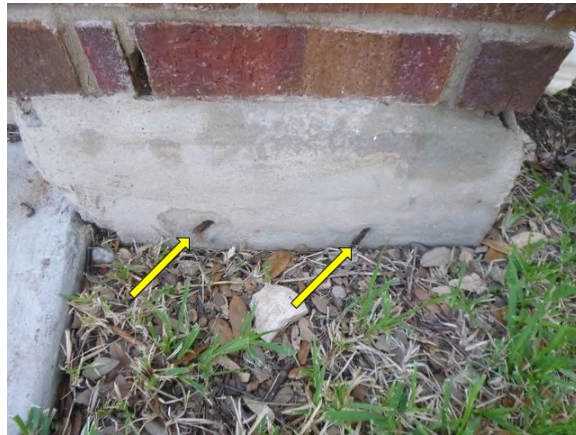
Exposed reinforcement. These areas should be covered with non-shrink grout to help prevent rusting.

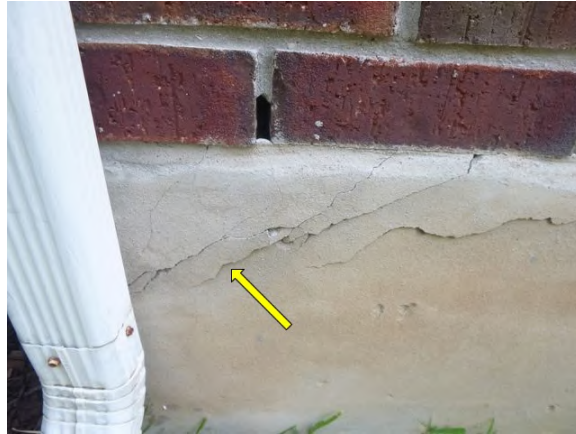
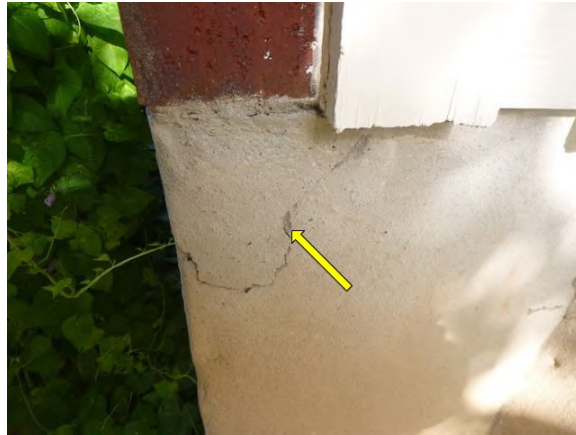
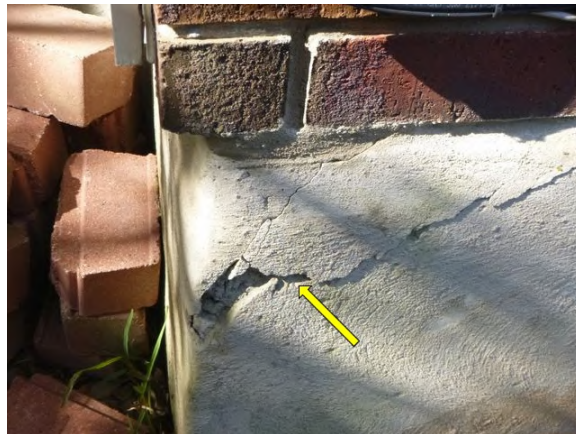
One or more foundation beam corners were observed to be sheared. Also known as a corner pop, this is common with slab on grade foundations. This condition usually does not adversely affect the foundation's performance. In some cases, cosmetic improvements may be necessary.

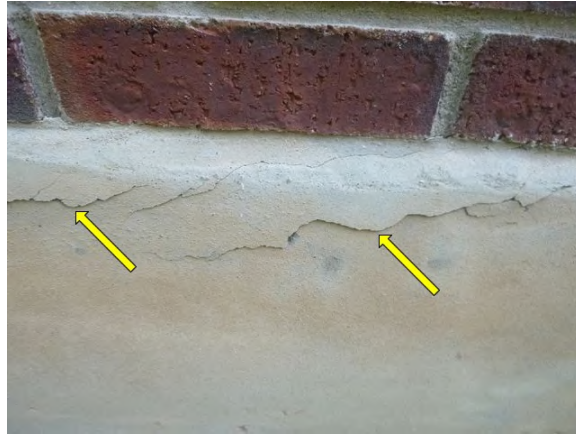
The parging is cracked or missing. This is merely cosmetic and does not affect the foundation's integrity. If in the future, however, the parging exposes post-tension cables or other metal foundation reinforcement it should be covered with a non-shrink grout.

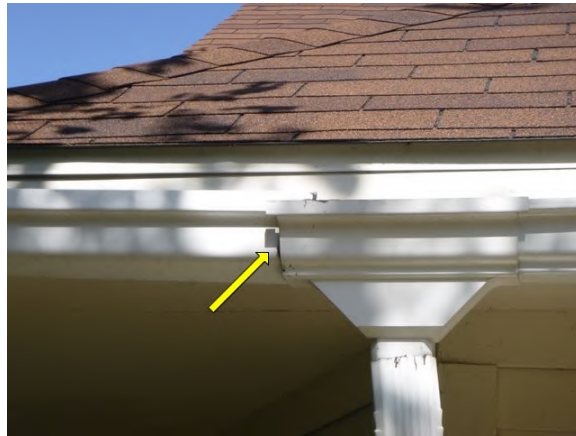
Vinyl gutter at rear of house is not secure at downspout.

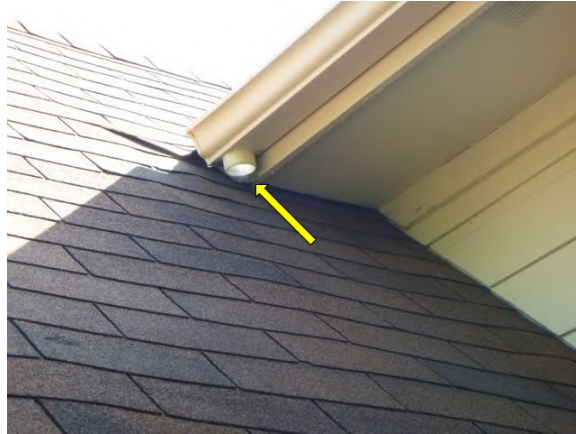
Gutters should not discharge onto roof covering materials. This decreases the useful life of roofing material and can lead to water penetration and wood rot. It is recommended that a downspout divert water off the roof covering materials.

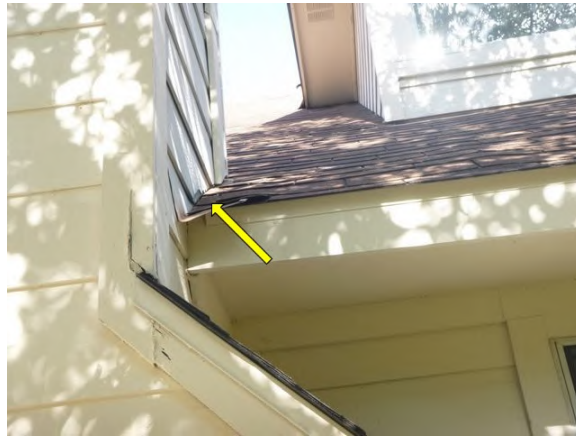
Missing kick out flashing on both side of chimney. Kick out flashing to used to divert water away from vertical surfaces.

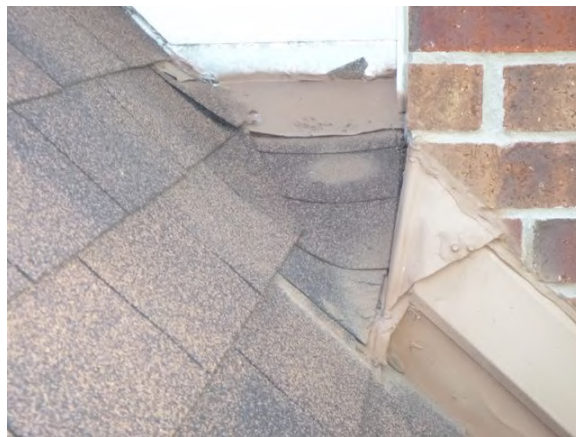
Exterior wall perpendicular to roof slope. This area has the potential to leak. Area should be monitored to ensured flashing and roof covering materials are functioning properly.

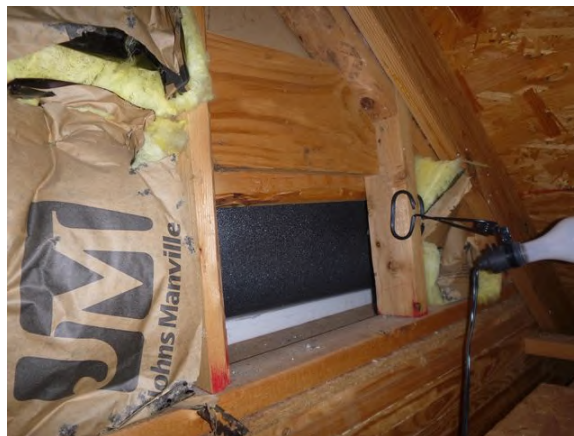
Missing insulation in stud bay. Insulation should also be reversed so that vapor barrier is closest to living space

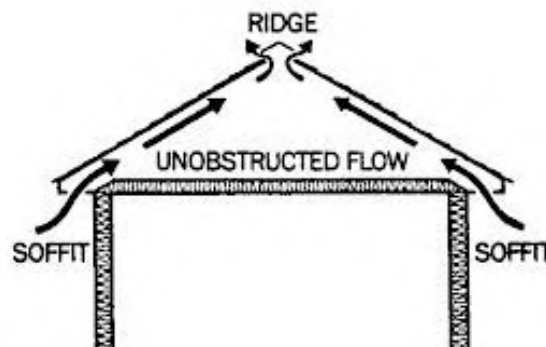
No ridge ventilation in small attic above the garage. Ventilation is required at the soffit

and near the ridge to adequately ventilate attic. See illustration above.

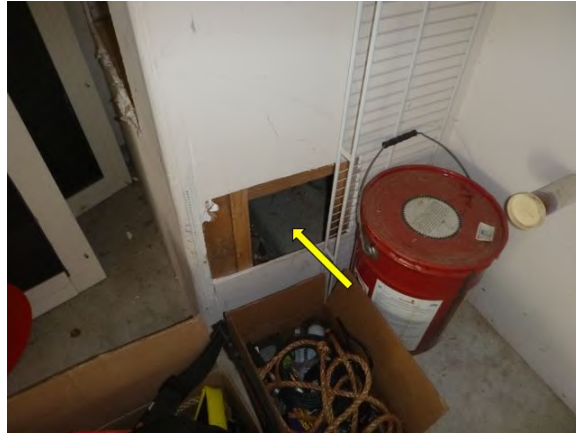
Area below water heater storage closet missing sheet rock.

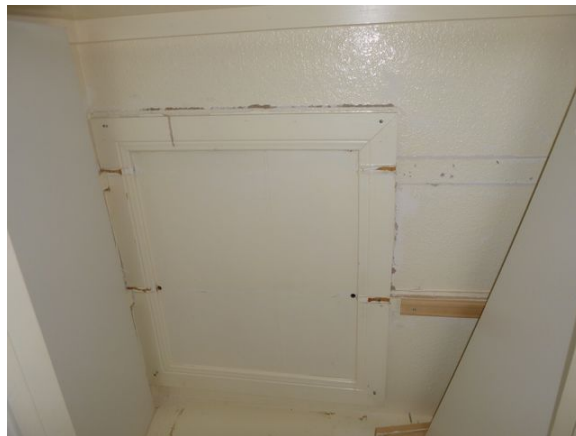
Attic access panel in closet should be re-secured to prevent air infiltration.

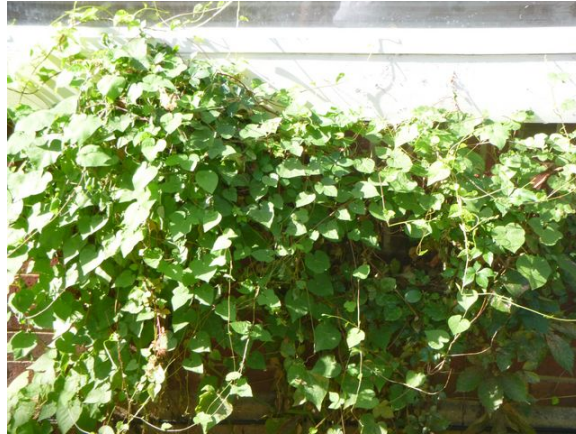
Trees/foliage are in contact with house's exterior. Allowing vegetation siding contact increases the risk of exterior cladding damage, and/or insect access.

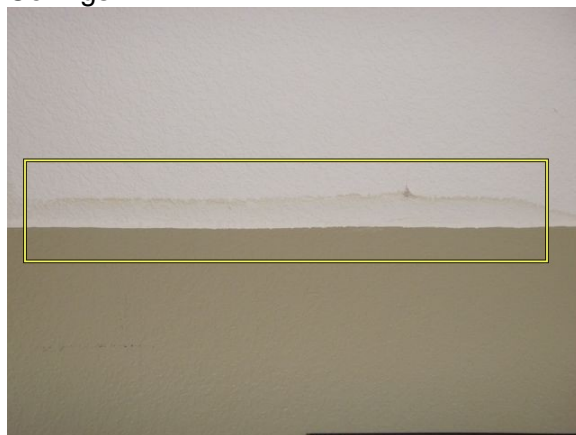
Evidence of previous water penetration above fireplace. A digital moisture meter did not detect excessive moisture at time of inspection.

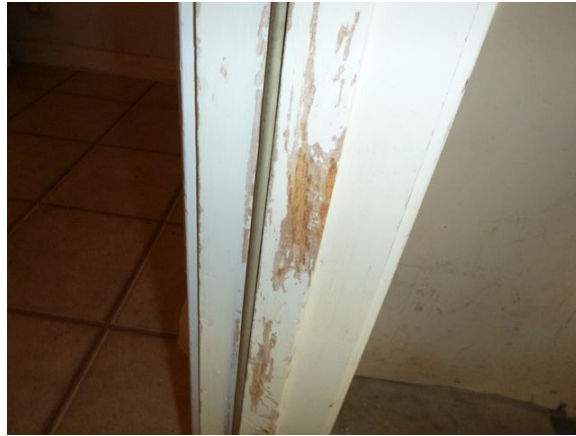
Damage to door jamb at entry to garage.

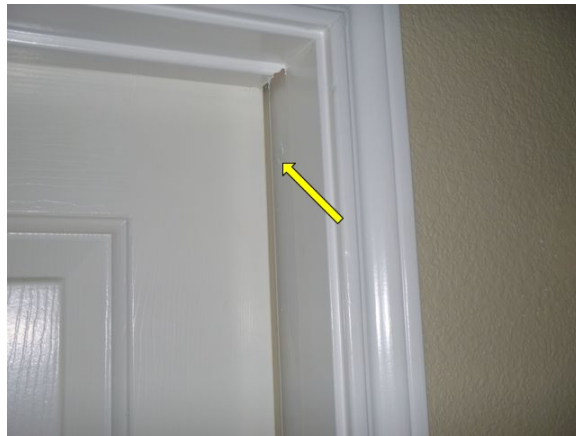
Missing vertical door stop on both sides to small room adjacent to bonus room.

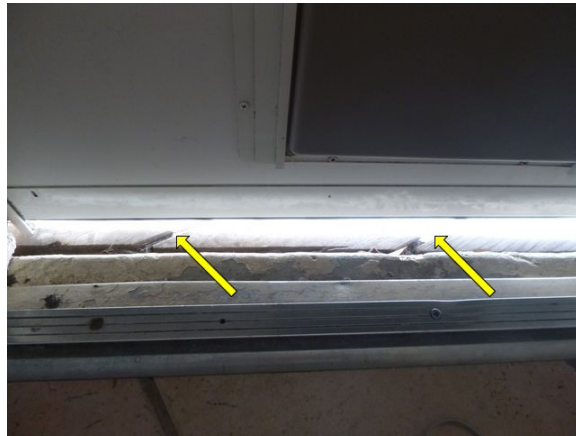
Rear storm door does not properly fit opening.

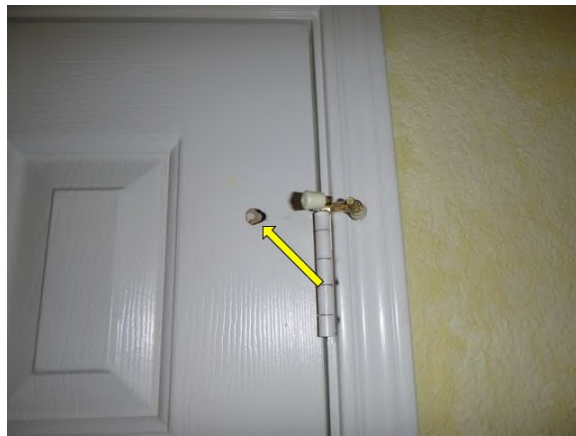
Small hole in left center bedroom closet door.

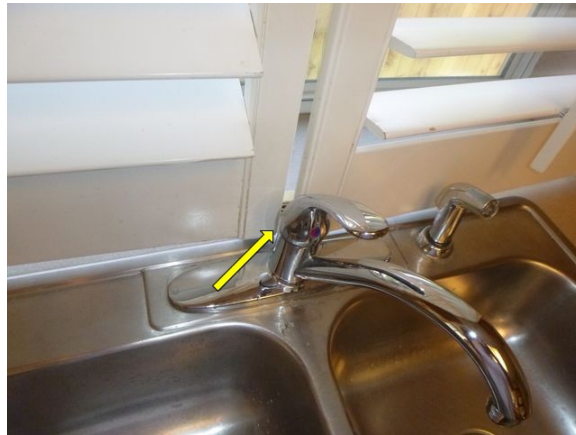
Kitchen fixture prevents opening plantation shutters behind sink. Unable to operate window.

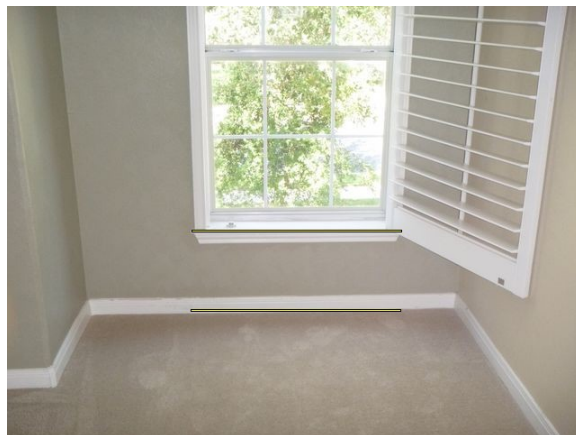
According to the International Residential Code (IRC) 2009 windows that are more than 72 inches above grade on the exterior must be at least 24 inches above the interior flooring unless proper window guards are installed. This is considered a safety hazards. Windows that do not meet this standards include but are not limited to the bonus room.

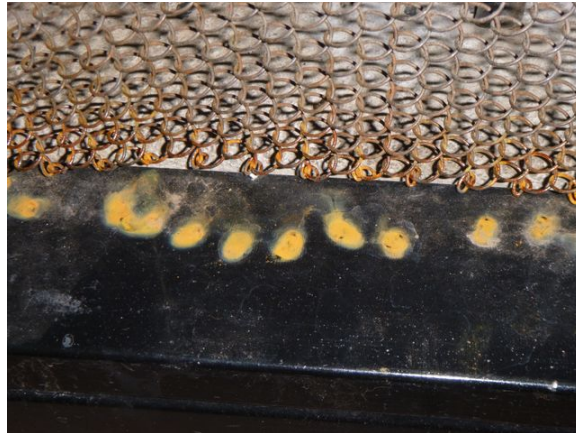
Evidence of water intrusion in fireplace. Unable to determine source, however, it is commonly caused by wind-driven rain down flue.

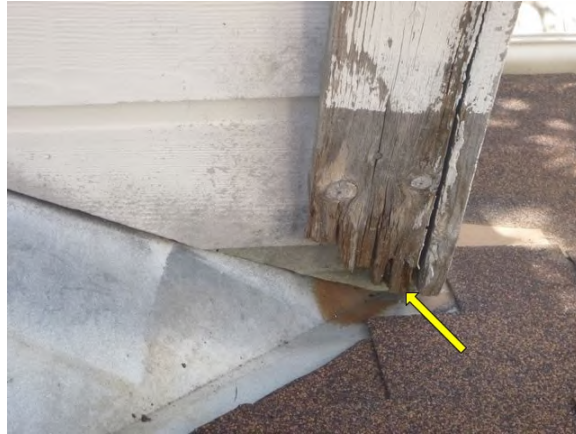
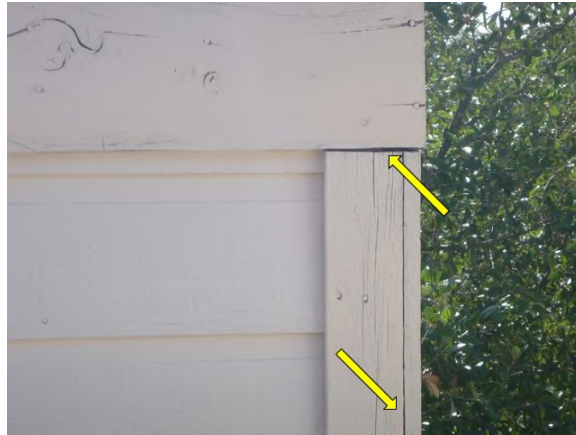
Chimney trim boards are beginning to show signs rot.

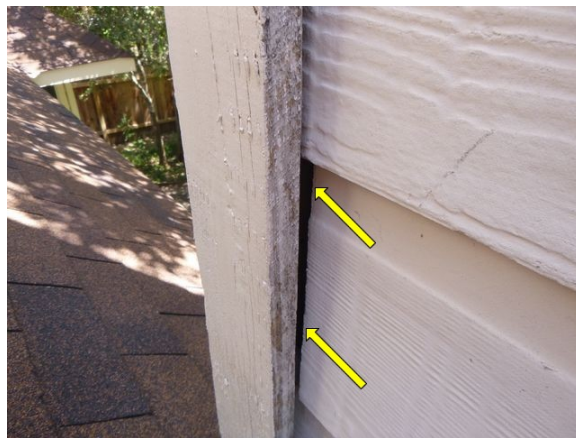
Vertical siding board cut too short.

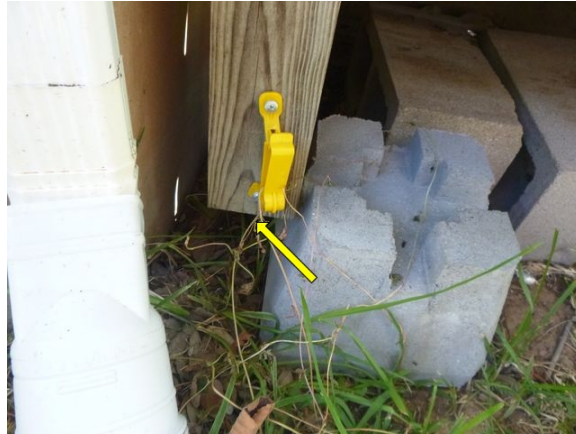
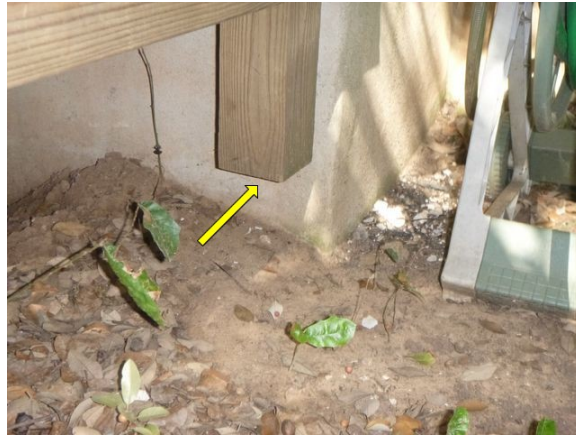
Unsupported piers near house.

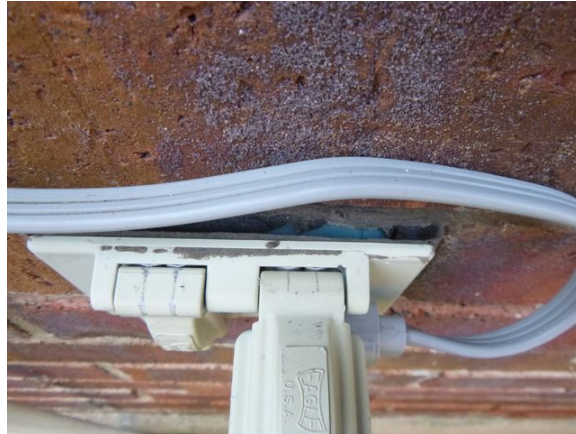
Missing outlet cover approved for wet location. According to IRC 2009 (Ref. 4002.9) all receptacles located in wet locations must have an in-use bubble cover. Bubble covers are required for all exterior locations except by front entry.

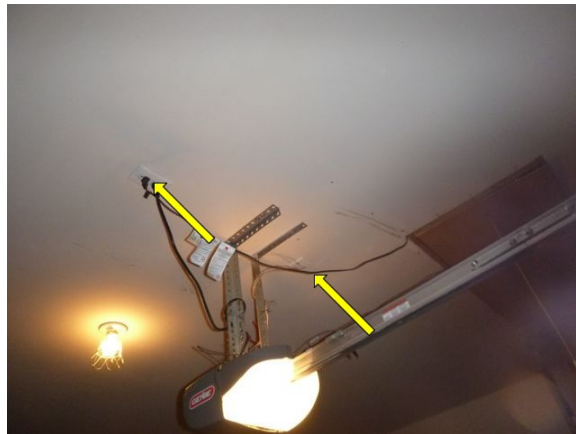
Improper use of extension cords. Current building standards does not allow of the long-term use of extension cords.

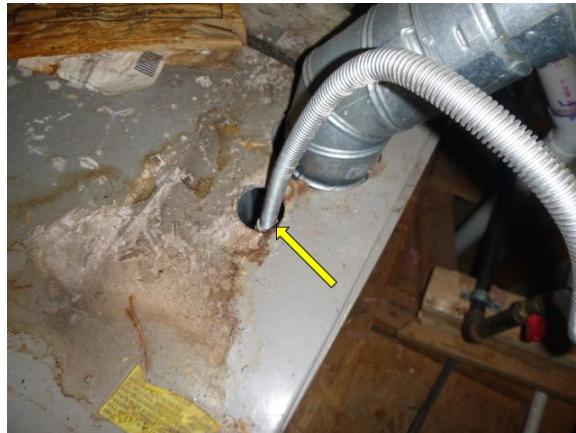
Gas supply line should not terminate inside furnace housing.

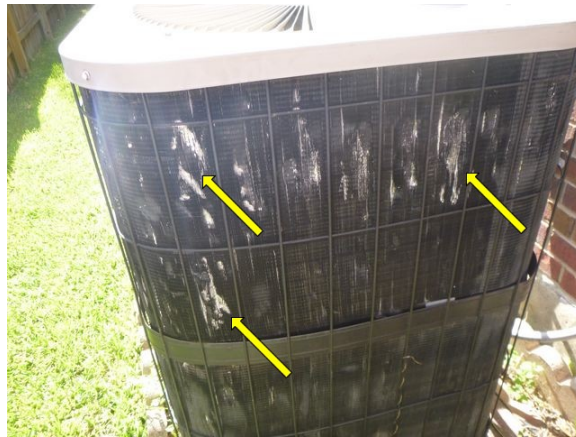
Condenser fins are damaged, possibly the result of hail.

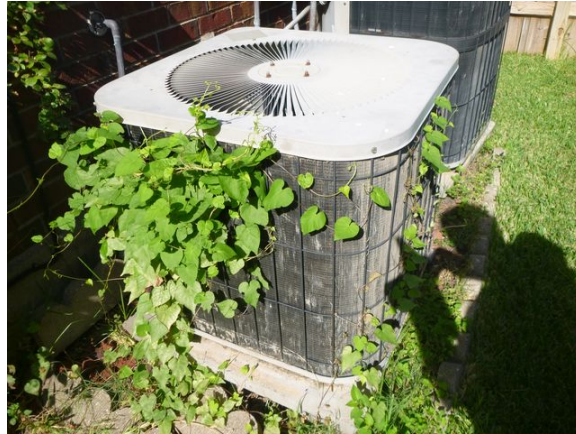
Vegetation growing on condenser fins reduces the efficiency of the unit and should be removed.

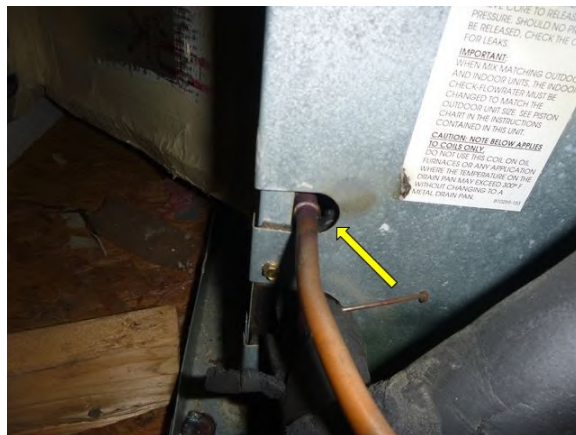
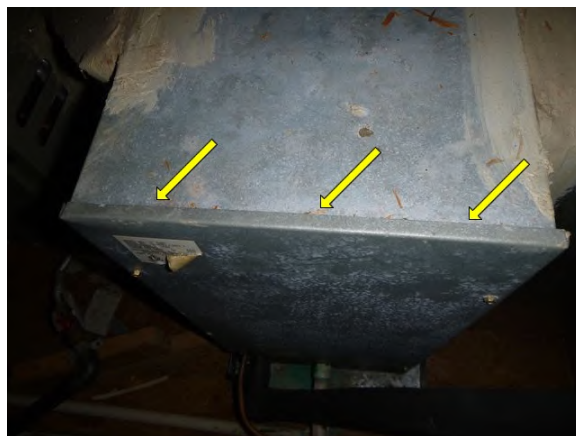
Significant air loss in evaporator coil housing. Areas highlight with yellow arrows should be sealed.

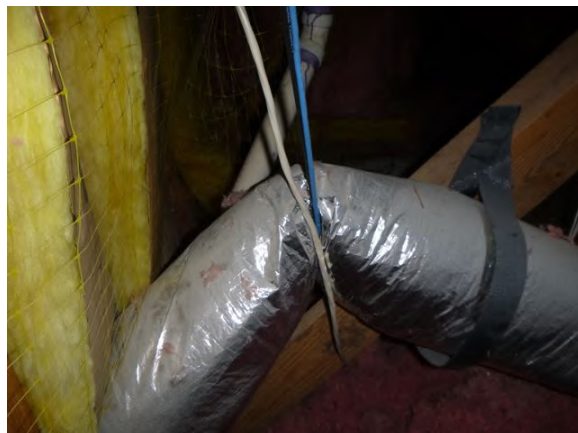
Kinked duct in HVAC system. Kinked ducts restrict air flow to designated areas and reduces the energy efficiency of the unit. Location: attic accessible in closet at top of stairs.

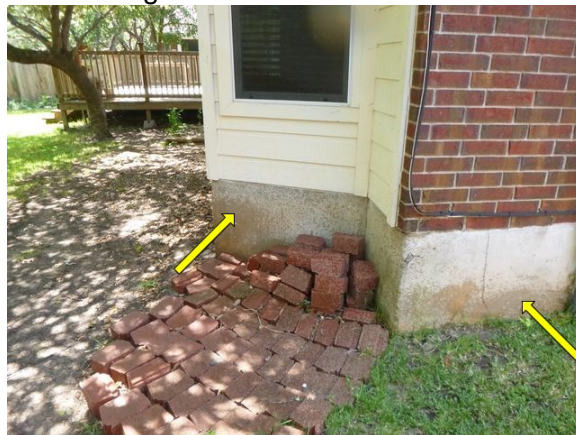
Zone 3: Right Rear

Spray heads should be readjusted to prevent over direct spray on wall
