Property Inspection Report for:

123 Main Street Unit 209
Austin, TX 78756

Report Number: Condo Report 7-5
Inspection Date: 02/22/2016

PROPERTY INSPECTION REPORT

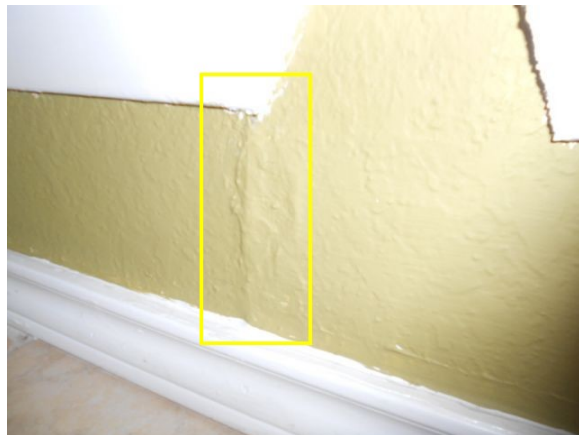
There is cosmetic damage on the wall underneath living room windows. A moisture meter did not detect excessive moisture.

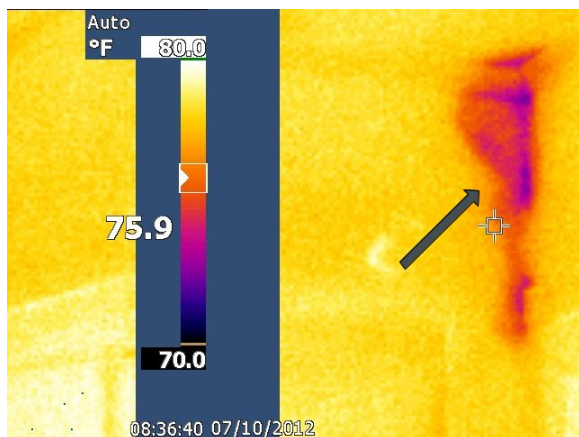
image 1

A thermal imaging camera detected a thermal variation in the ceiling and wall adjacent to balcony door (image 1). Further investigation with a moisture meter revealed the presence of excessive moisture (image 2). The exterior wall is highlighted by the yellow arrow and includes the downspout (image 3). The interior moisture intrusion is located at the corner on the left side of the balcony door and possible related to the downspout.

Moisture intrusion, left uncorrected, can create several major issues and lead to expensive repairs. Recommend notifying the condominium owners association or other appropriate authority and discuss steps needed to make repair. At time of inspection there was evidence of recent rainfall.

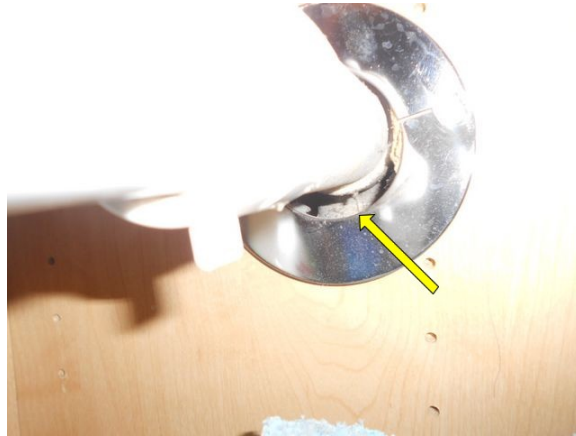
Penetrations under bath lavatory should be sealed to prevent pest intrusion and air loss/infiltration.

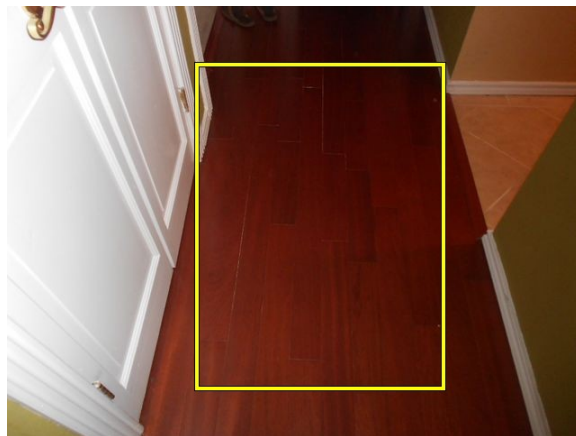
The area underneath the wood floor has a void. Excessive deflection was present when walked on.

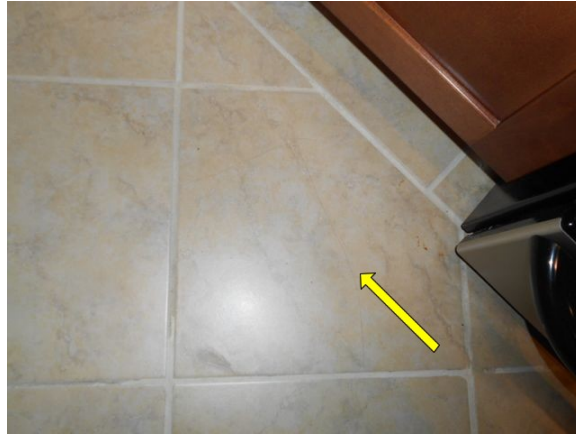
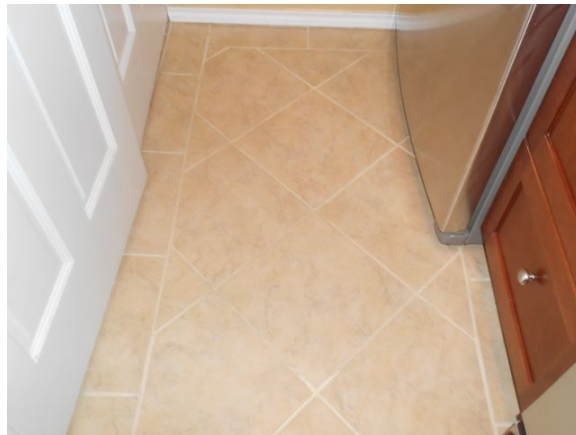
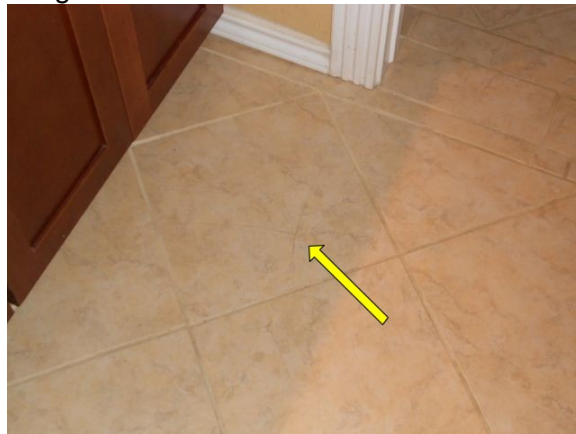
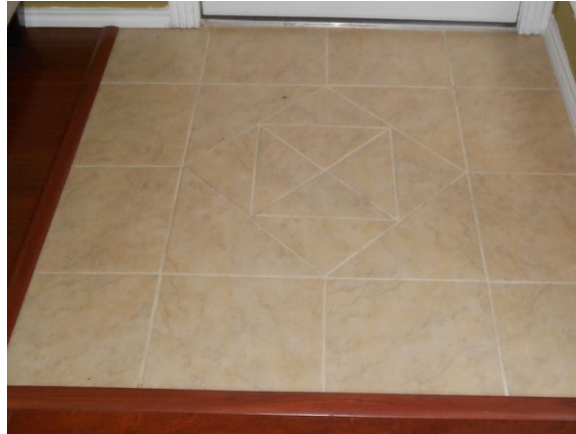
All tile areas have cracked, loose and/or raised tile(s). When systemic tile deficiencies are present it is commonly related to improper floor preparation or installation. Recommend that a floor specialist evaluate tile floor. Images 1 and 2 are the kitchen; image 3 the bathroom; and image 4 the entry. Note: Images are for reference only and do not reveal all deficiencies.

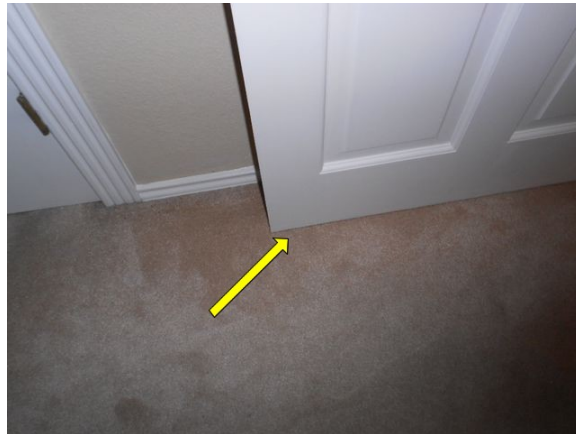
Second bedroom door drags on the carpet. Trimming the bottom of the door to prevent physical damage to carpet is recommended.

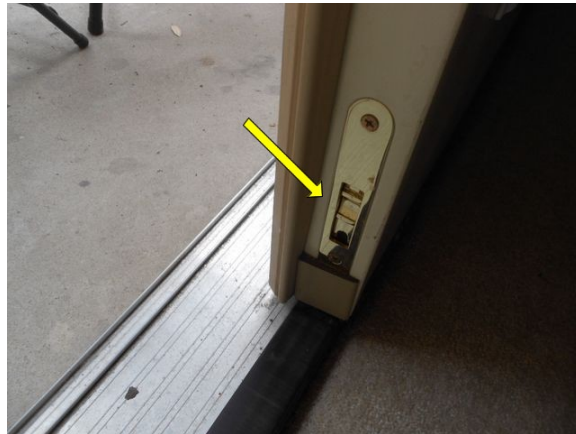
Bottom pin on French doors does not extended into threshold. This prevent the proper locking of the door and should be repaired.

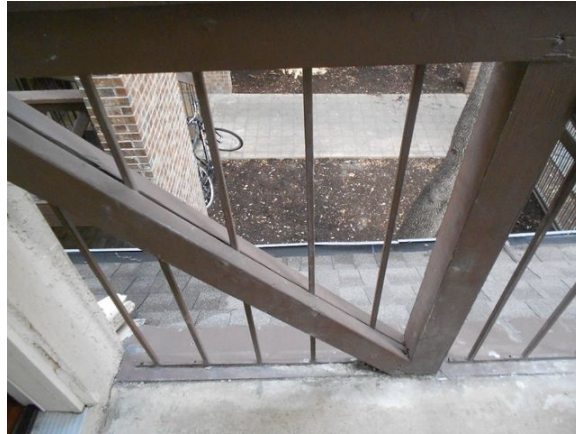
The balusters exceed the maximum spacing. International Residential Code states that openings between balusters may not allow a 4 inch sphere to pass through. While this is owned and maintained by the condominium owners association it is a considered a small child safety hazard and should be noted.

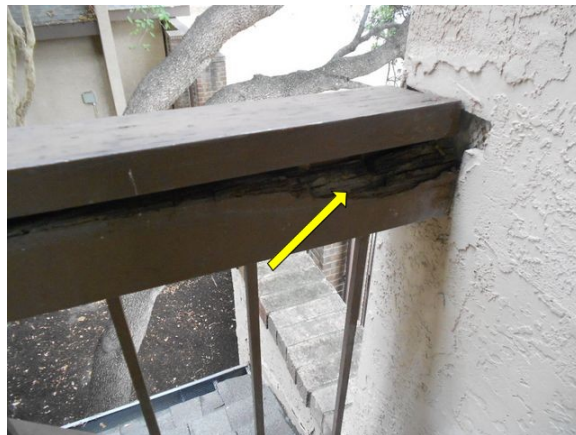
Damage to railing on balcony. While this is owned and maintained by the condominium owners association it should be noted.

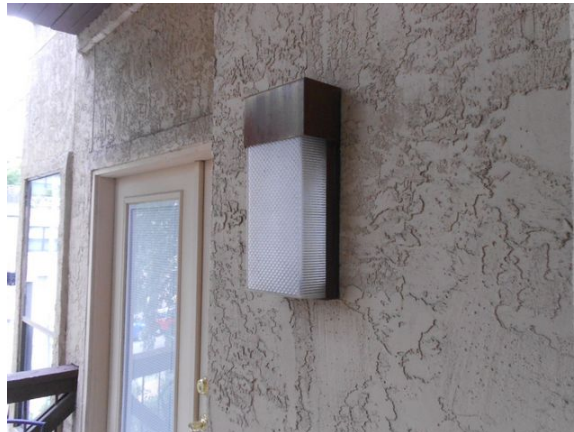
Inoperative light on balcony. This is possibly the result of an inoperative bulb.

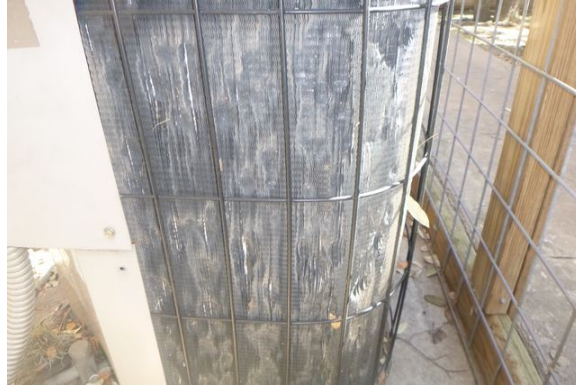
The condenser fins are significantly damaged on one side of the unit. This decreases the components efficiency and lifespan.

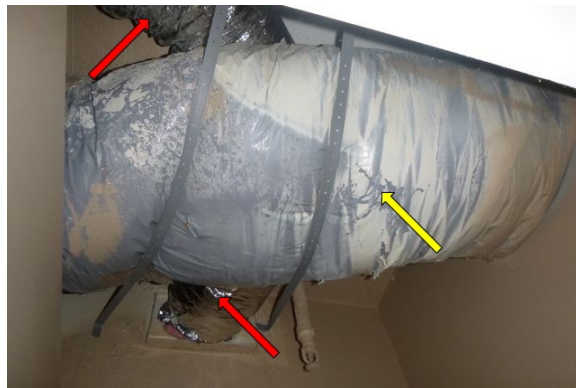
Gray ductwork is considered a defective product and is no longer manufactured. While once a common product it has not been used since the early 1990s. Manufacturers of this type of ductwork have been defendants in class-action lawsuits because of its susceptibility to deterioration when exposed temperatures commonly found in attic spaces. However, the visible sections of existing duct appear to be functioning as

intended and in acceptable condition. (yellow arrow) Some duct runs have been replaced. (red arrows)

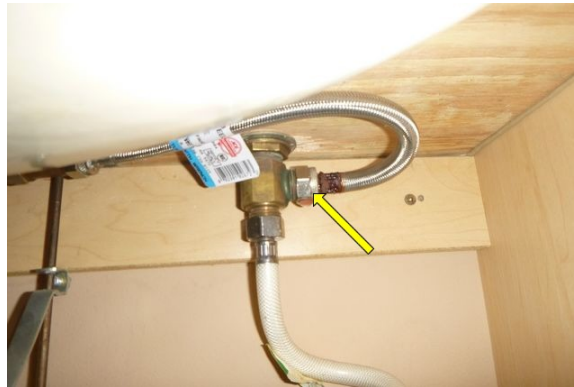
There is a active leak when the master bathroom faucet is in use. It is located where the supply hose joins hot water valve. Replacing the hose is recommended before using faucet to prevent water damage to floor, cabinet and wall.

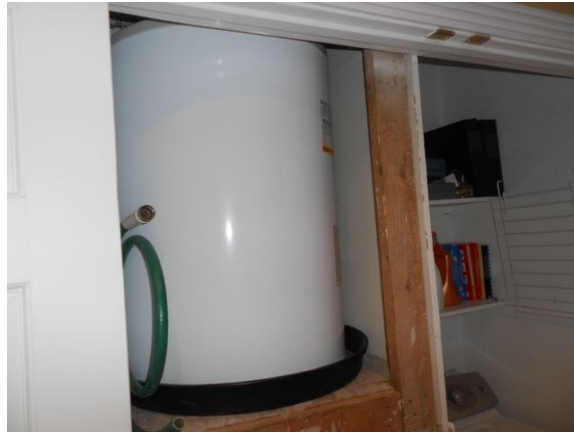
Water heater is located in a sealed compartment above the dryer unit. Image above shows panel removed.

The drain pan is present but lack a pipe to discharge water to the exterior. Drain pans were not required at time of construction and retrofitting would be difficult.

Rear of unit is inaccessible; unable to determine if temperature pressure relief valve is properly connected and drains to outside. Temperature pressure relief valve should terminate into a easily visible location.

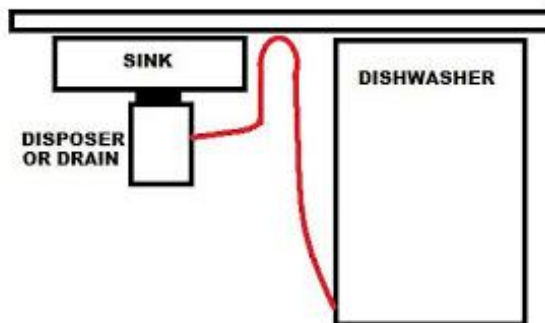
Dishwasher drain line needs to be elevated and be securely fastened to the underside of the countertop above side inlet to disposal. This prevent debris and gray water from draining down line from disposal and back into dishwasher. An alternative is an air gap device installed on countertop.
