Property Inspection Report for:

123 Main Street
Round Rock, TX 78681

<p>Prepared For: John & Jane Doe Report Number: Sample Report 7-5 Inspection Date: 02/07/2016</p>	<p>Inspected By: John Goodin TREC# 20201 Phone: 512-431-0660 Email: john@homescientific.com Web: homescientific.com</p>
--	--

PROPERTY INSPECTION REPORT

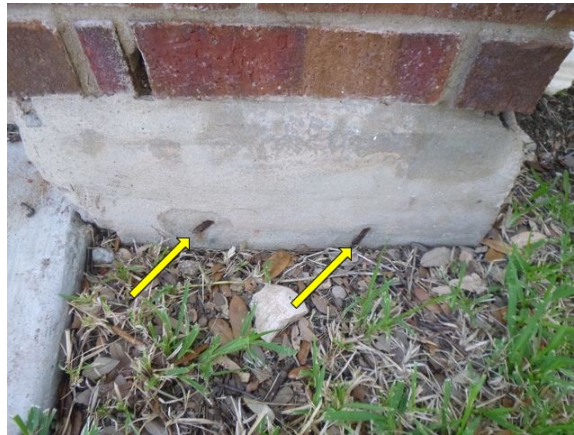
There is exposed reinforcement on the slab. These areas should be covered with non-shrink grout to help prevent rusting.

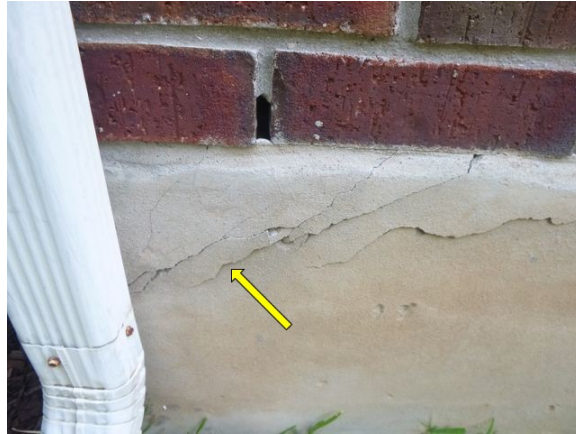
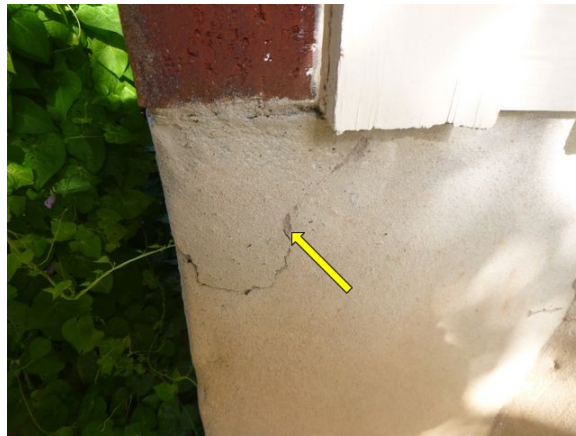
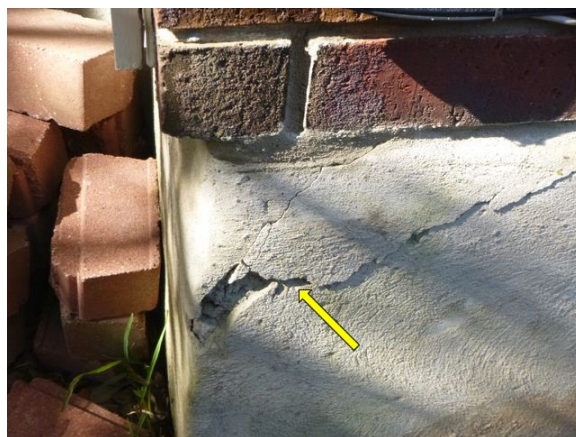
One or more foundation beam corners were observed to be sheared. Also known as a corner pop, this is common with slab on grade foundations. This condition usually does not adversely affect the foundation's performance. In some cases, cosmetic improvements may be necessary.

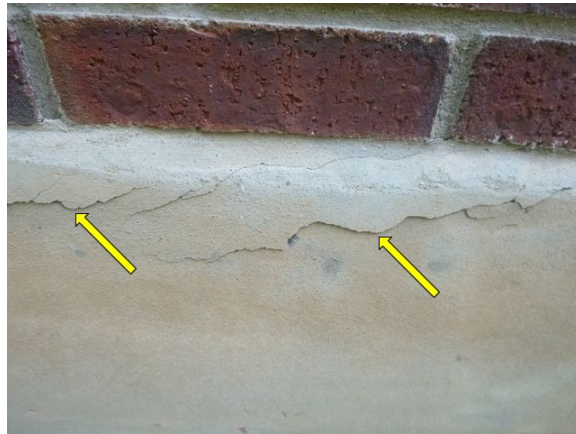
The parging is cracked or missing. This is merely cosmetic and does not affect the foundation's integrity. If in the future, however, the parging exposes post-tension cables or other metal foundation reinforcement it should be covered with a non-shrink grout.

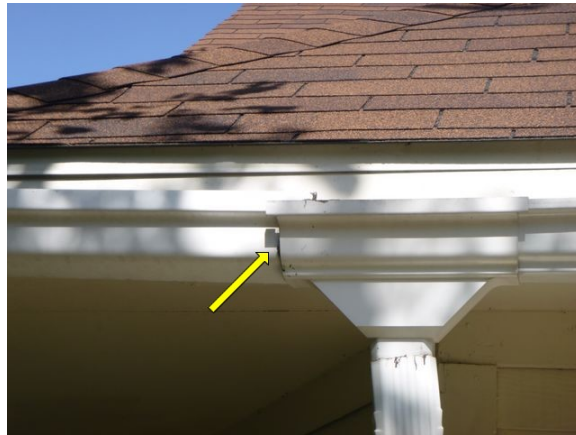
The vinyl gutter at rear of house is not secure at downspout. This can allow improper drainage to the patio below.

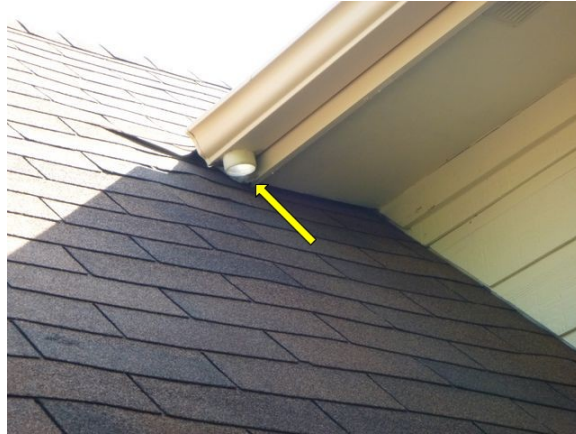
Gutters should not discharge onto roof covering materials. This decreases the useful life of roofing material and can led to water penetration and wood rot. It is recommended that a downspout divert water off the roof covering materials.

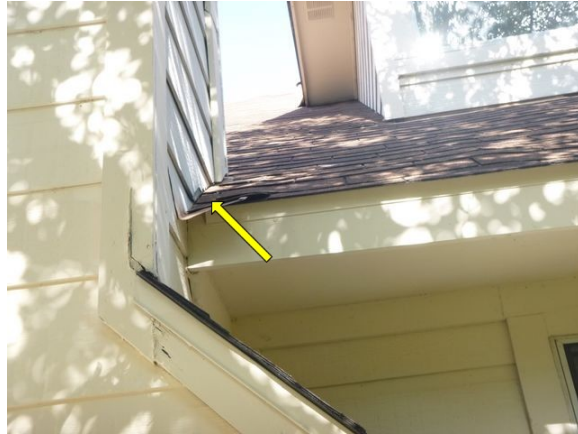
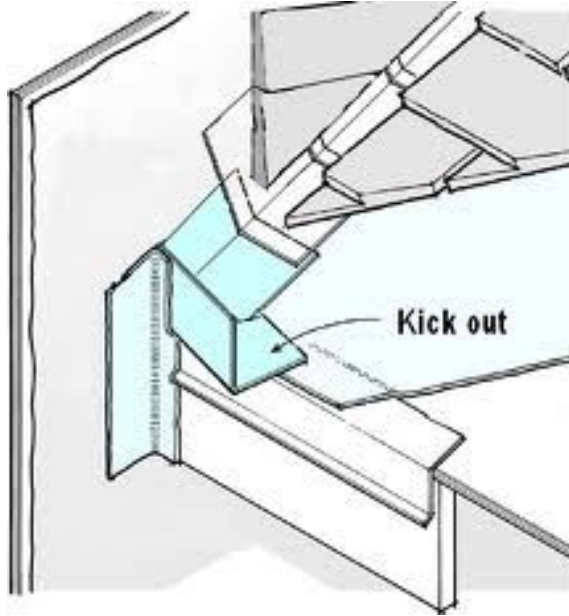
Missing kick out flashing on both side of chimney. Kick out flashing to used to divert water away from vertical surfaces. See image below.

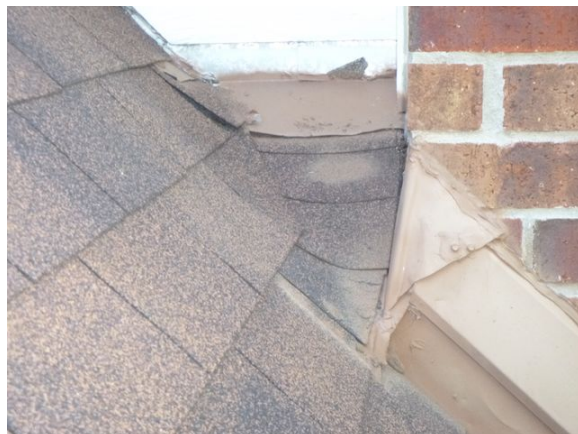
Exterior wall perpendicular to roof slope. This area has the potential to leak. Area should be monitored to ensure flashing and roof covering materials are functioning properly.

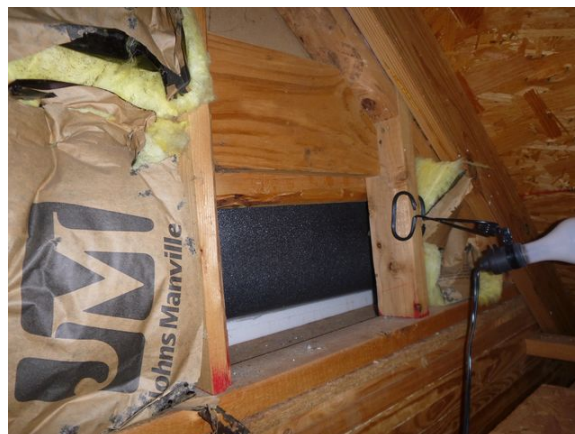
There is insulation missing in stud bay. Insulation should also be reversed so that vapor barrier is closest to living space

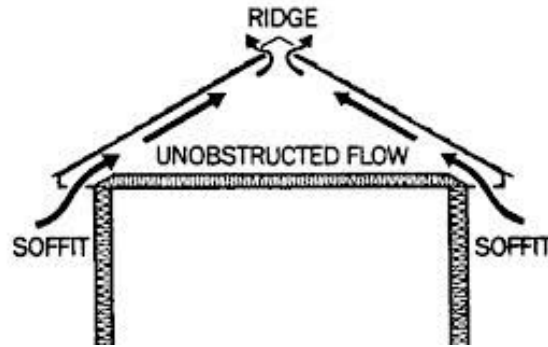
There is no ridge ventilation in small attic above the garage. Ventilation is required at the soffit and near the ridge to adequately ventilate attic. See illustration above.

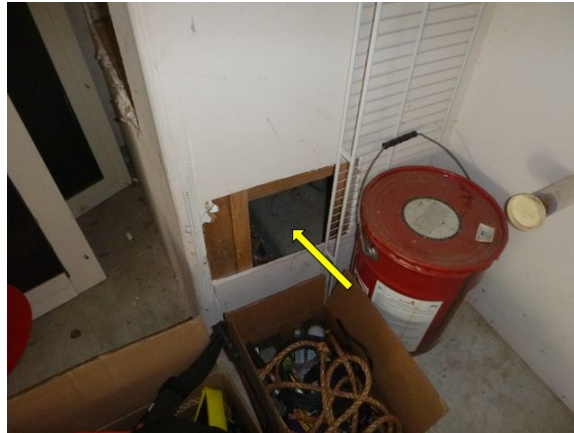
The area below water heater storage closet is missing sheet rock.

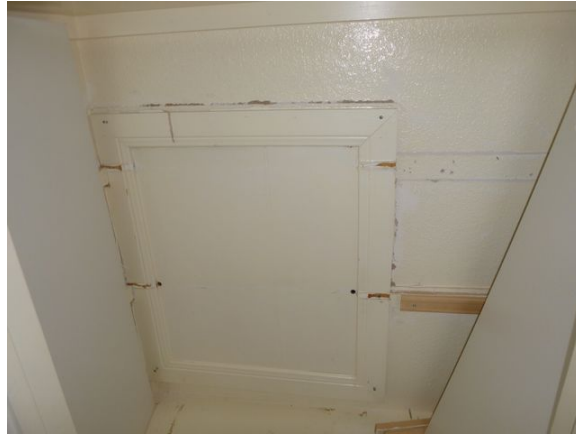
Attic access panel in closet should be re-secured to prevent air infiltration.

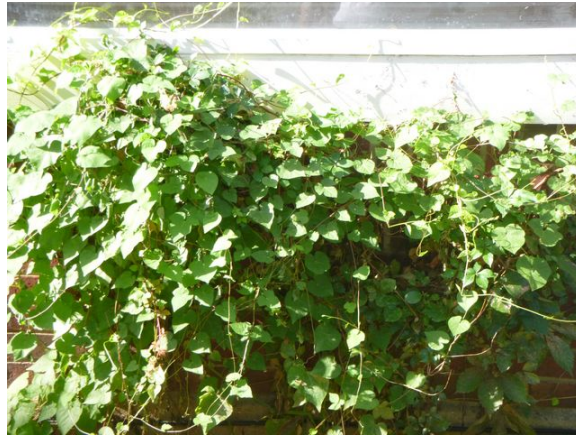
Trees/foliage are in contact with house's exterior. Allowing vegetation siding contact increases the risk of exterior cladding damage, and/or insect access.

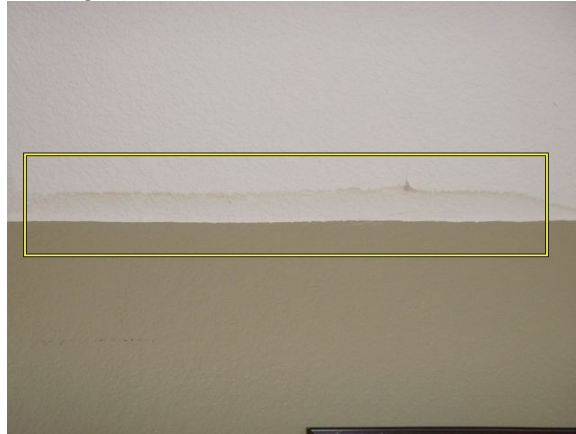
Evidence of previous water penetration above fireplace. A digital moisture meter did not detect excessive moisture at time of inspection.

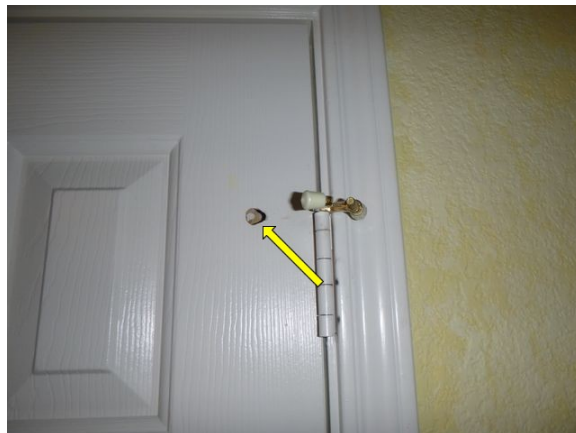
There is a small hole in left center bedroom closet door.

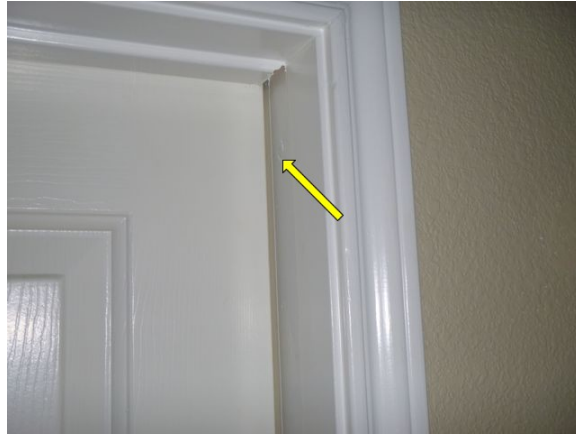
Missing vertical door stop on both sides to small room adjacent to bonus room.

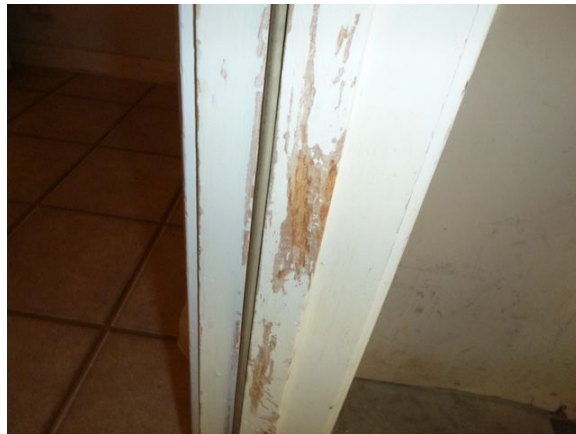
There is damage to the door jamb at entry to garage.

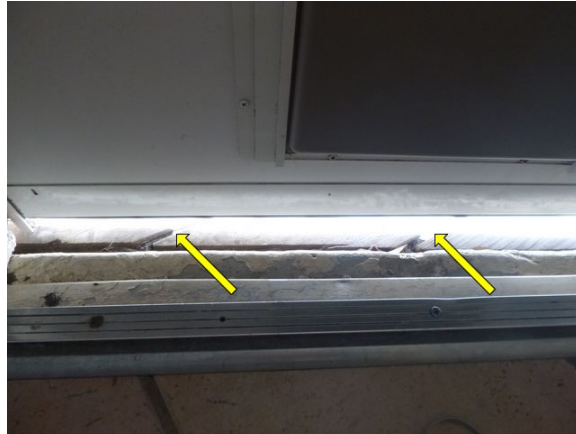
Rear storm door does not properly fit opening.

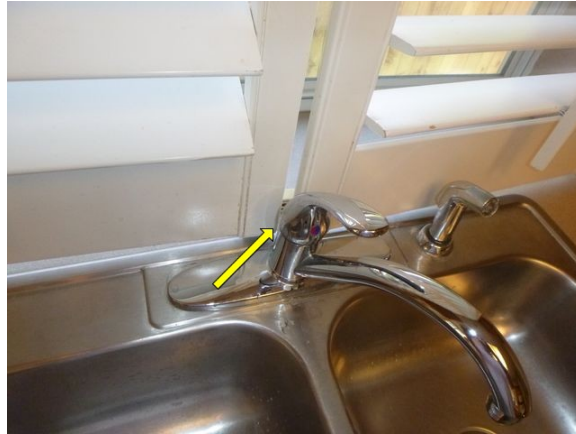
Kitchen fixture prevents opening plantation shutters behind sink. Unable to operate window.

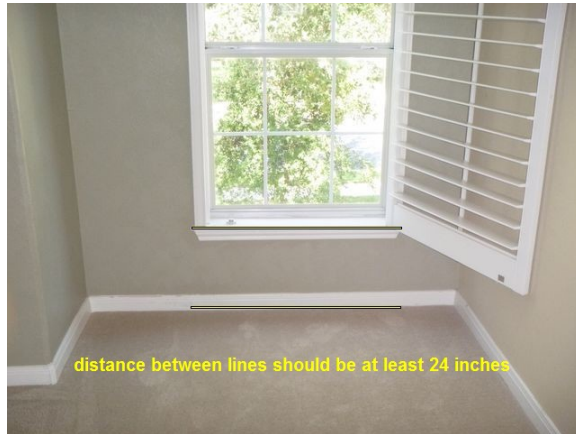
According to the International Residential Code (IRC) 2009 windows that are more than 72 inches above grade on the exterior must be at least 24 inches above the interior flooring unless proper window guards are installed. This is considered a safety hazard. Windows that do not meet this standards include but are not limited to the bonus room.

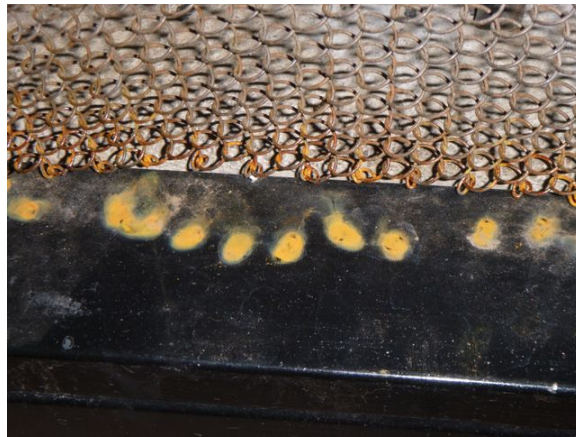
Evidence of water intrusion in fireplace. Unable to determine source, however, it is commonly caused by wind-driven rain down flue.

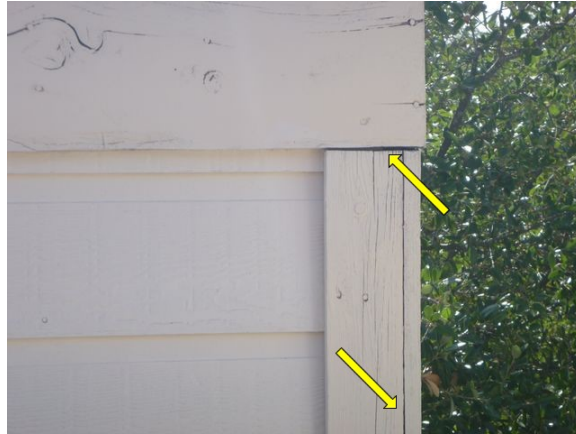
Chimney trim boards are beginning to show signs rot.

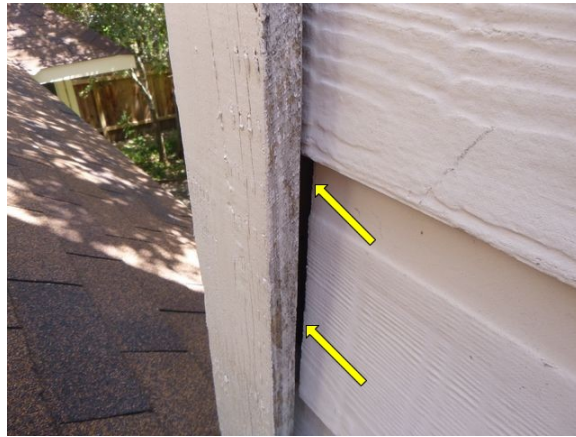
Vertical siding board cut too short.

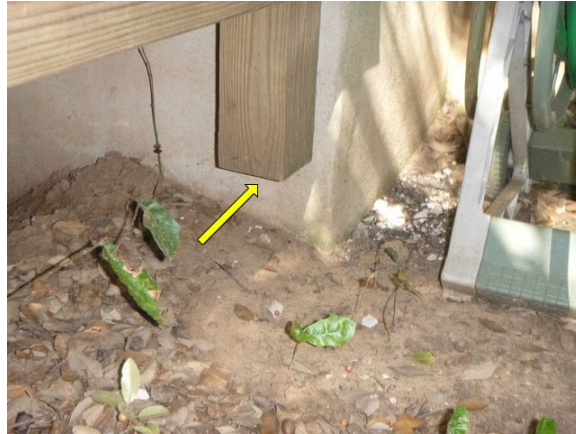
Unsupported piers near house.

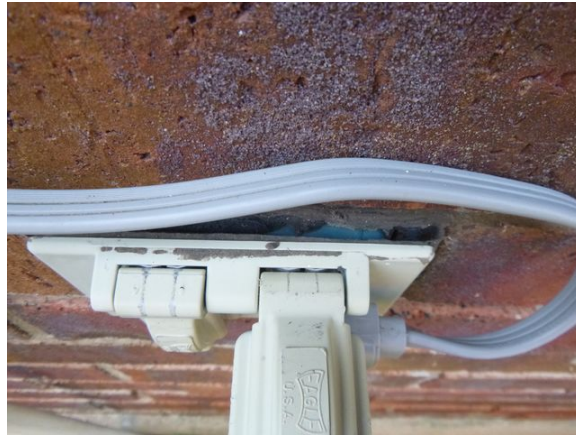
Missing outlet cover approved for wet location. According to IRC 2009 (Ref. 4002.9) all receptacles located in wet locations must have an in-use bubble cover. Bubble covers are required for all exterior locations except by front entry.

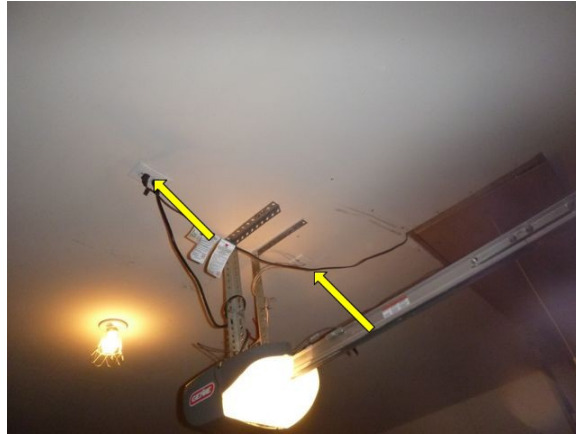
Improper use of extension cords. Current building standards does not allow of the long-term use of extension cords.

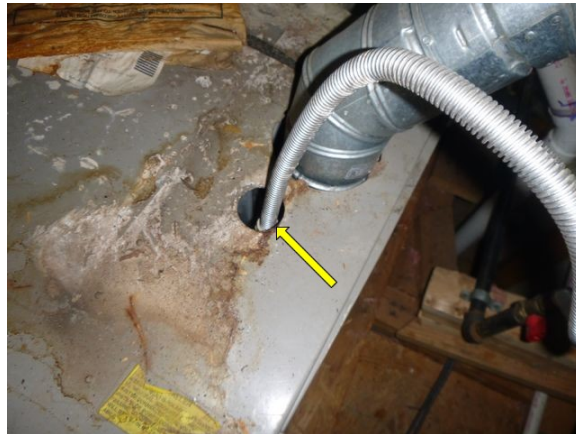
Gas supply line should not terminate inside furnace housing.

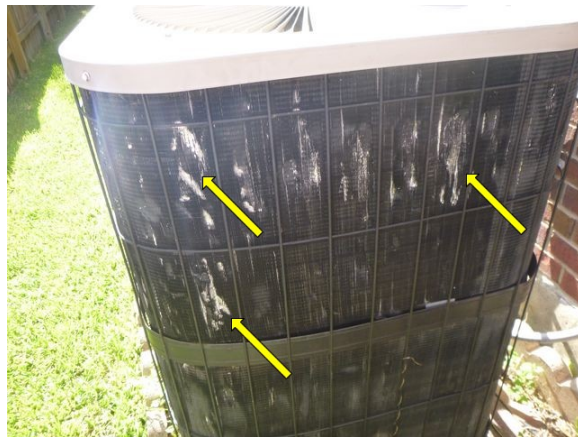
Condenser fins are damaged, possibly the result of hail.

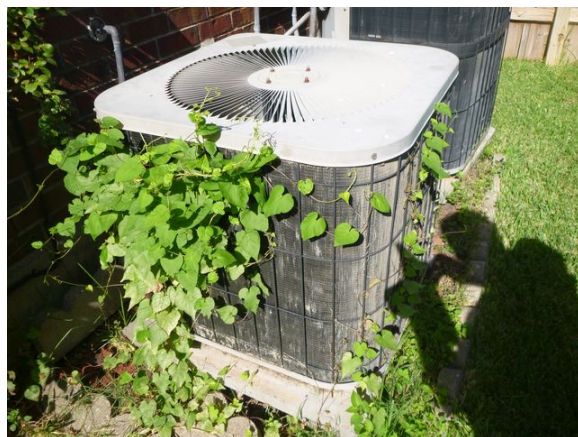
Vegetation growing on condenser fins reduces the efficiency of the unit and should be removed.

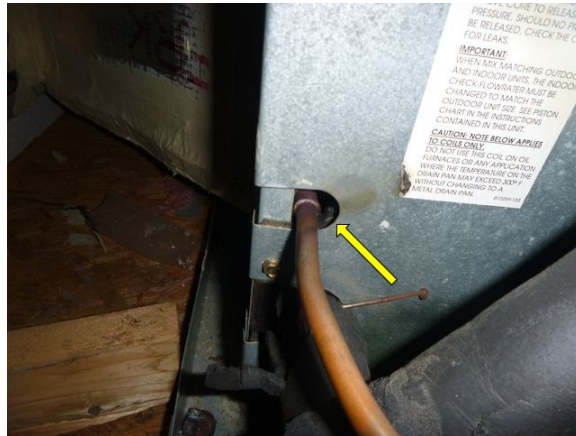
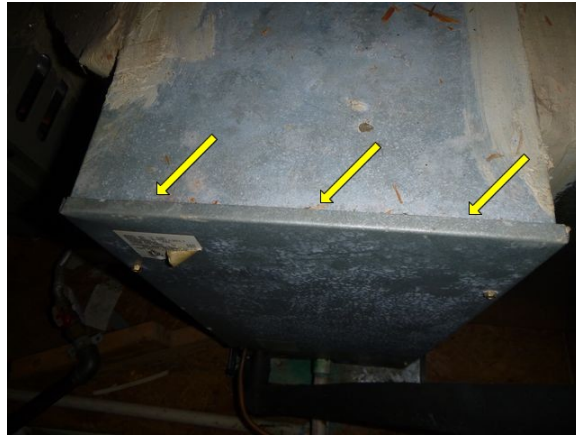
Significant air loss in evaporator coil housing. Areas highlight with yellow arrows should be sealed.

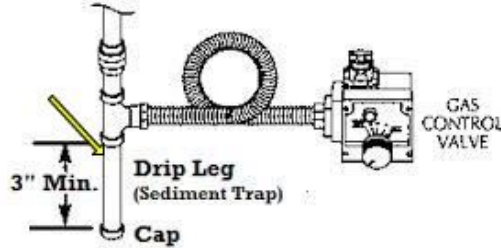
All required drip legs were not present. A drip leg is a small, capped off section of gas line which is installed in such a way that any debris or moisture in the gas line will be caught in the trap. See image below.

Drip leg(s) were missing at the furnace water heater other

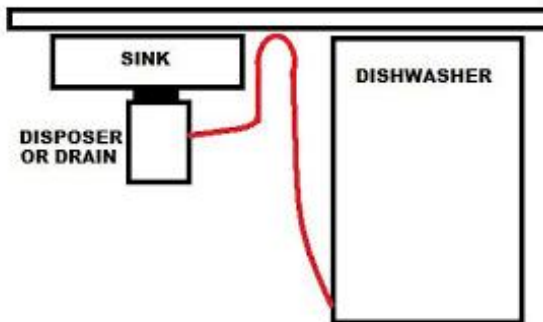
Dishwasher drain line needs to be elevated and be securely fastened to the underside of the countertop above side inlet to disposal. This prevents debris and gray water from draining down line from disposal and back into dishwasher. An alternative is an air gap device installed on countertop. See image below.

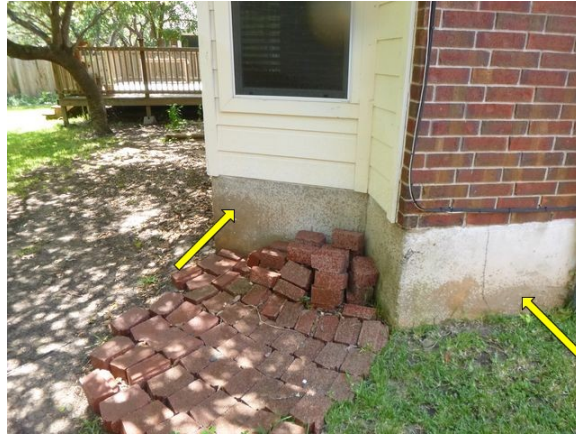
Spray heads should be readjusted to prevent over direct spray on wall
