Property Inspection Report for:

123 Main Street
Round Rock, TX 78681

<p>Prepared For: John & Jane Doe Report Number: Sample Report 7-5 Inspection Date: 02/07/2016</p>	<p>Inspected By: John Goodin TREC# 20201 Phone: 512-431-0660 Email: john@homescientific.com Web: homescientific.com</p>
--	--

PROPERTY INSPECTION REPORT

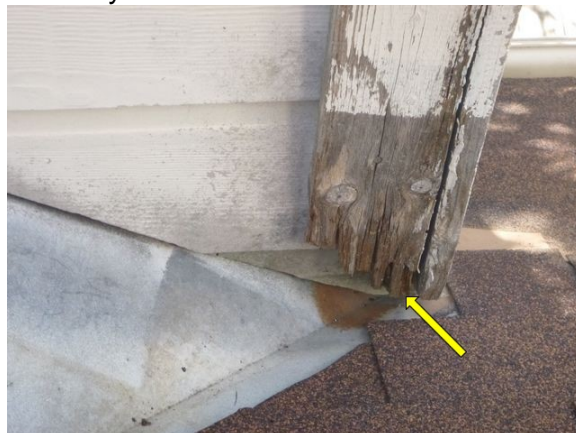
Chimney:

Evidence of water intrusion in fireplace. Unable to determine source, however, it is commonly caused by wind-driven rain down flue.
